FORTH PORTS

Grating Survey Report

PORT OF ROSYTH

INSPECTION AREA: Marine Bridge

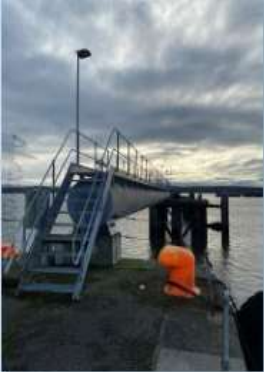
<p>The Dolphin Access Bridge is in 2 sections and has clamped grating along both sections.</p> <p>All access step gratings are bolted in place.</p>	Clamps	Good	<p>Clamps are end to end and grating to grating meaning that they are not actually secured to the bridge structure.</p> <p>On Section 1 of the Access Bridge (nearest the quayside) there were 36 panels with 12 loose clips.</p> <p>On Section 2 of the Access Bridge there were 33 panels with 8 loose clips</p>	Whole equipment review required with clips requiring either tightening or replacing into correct position.	GV & RJ

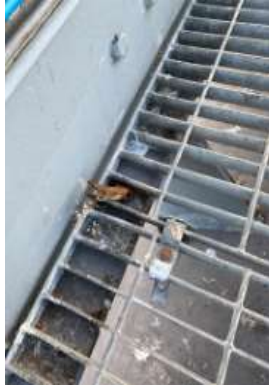
2

Example of clamps positioning

Some claps have been placed wrongly and are only connected to one piece of grating.

Replace clips to connect GV & RJ grating

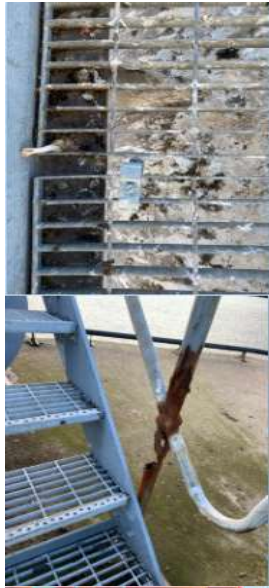
3

Section 2 of the bridge: R/Hand Handrail Station is severely corroded and in need of repair / replacement

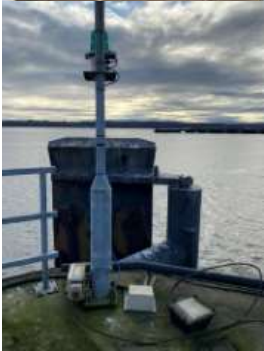
5

A light has fallen off of its bracket at the end of the bridge pier
