Grating / Grating Securing

Port of Leith

Unsafe Floor Grating

Safety Alert

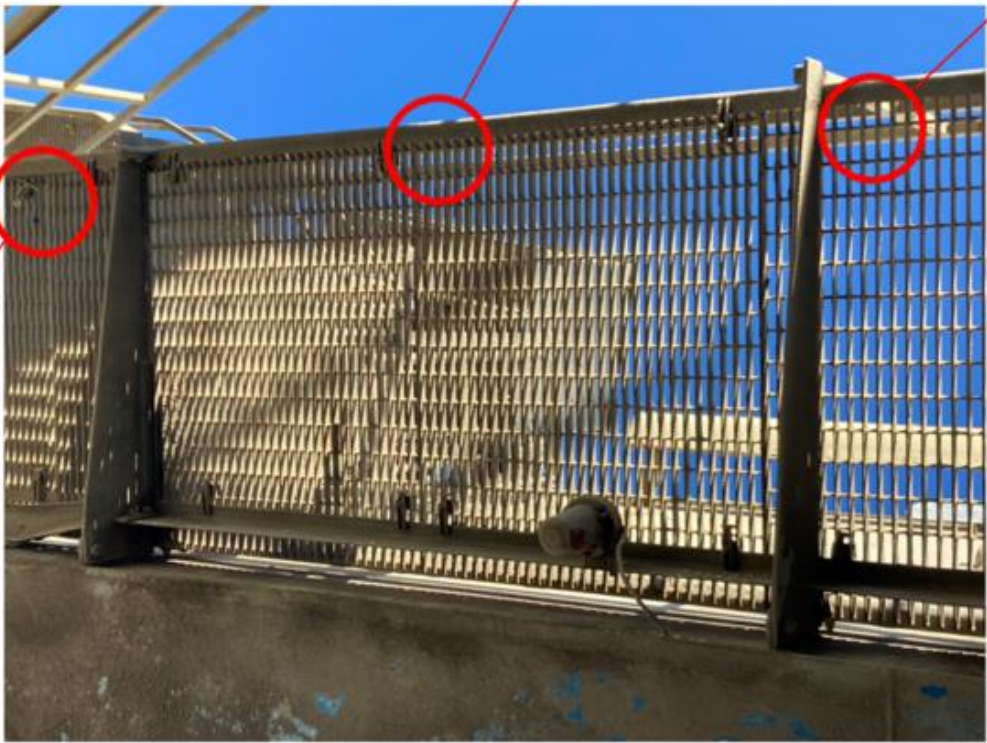
Clip missing?

Clip Loose / hanging?

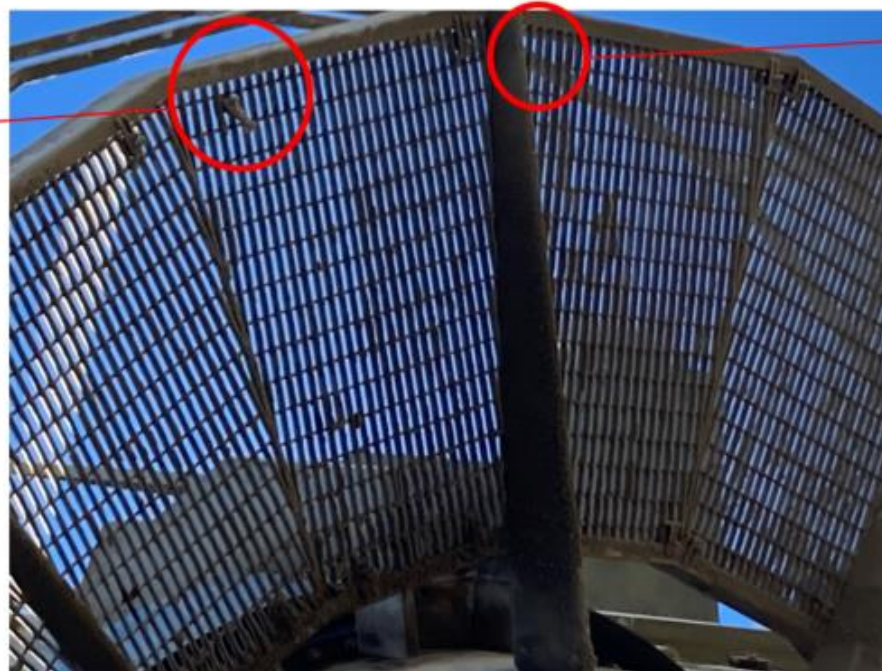
Clip Loose

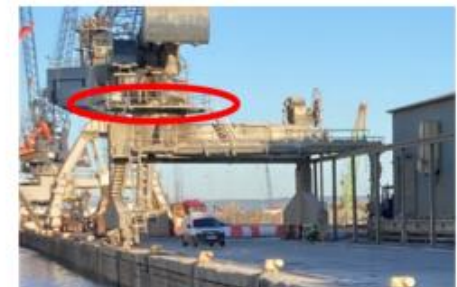
Potentially a clip missing?

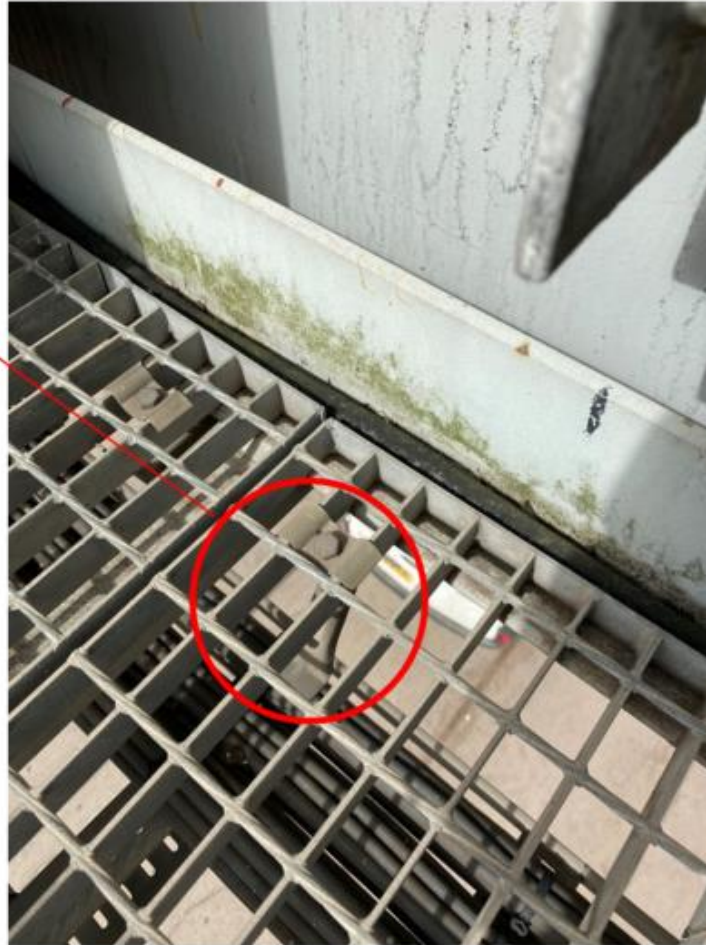
Crane 42 (1st Level)
*Looking for evidence &
seeing the indicators*

Clip Loose /
hanging

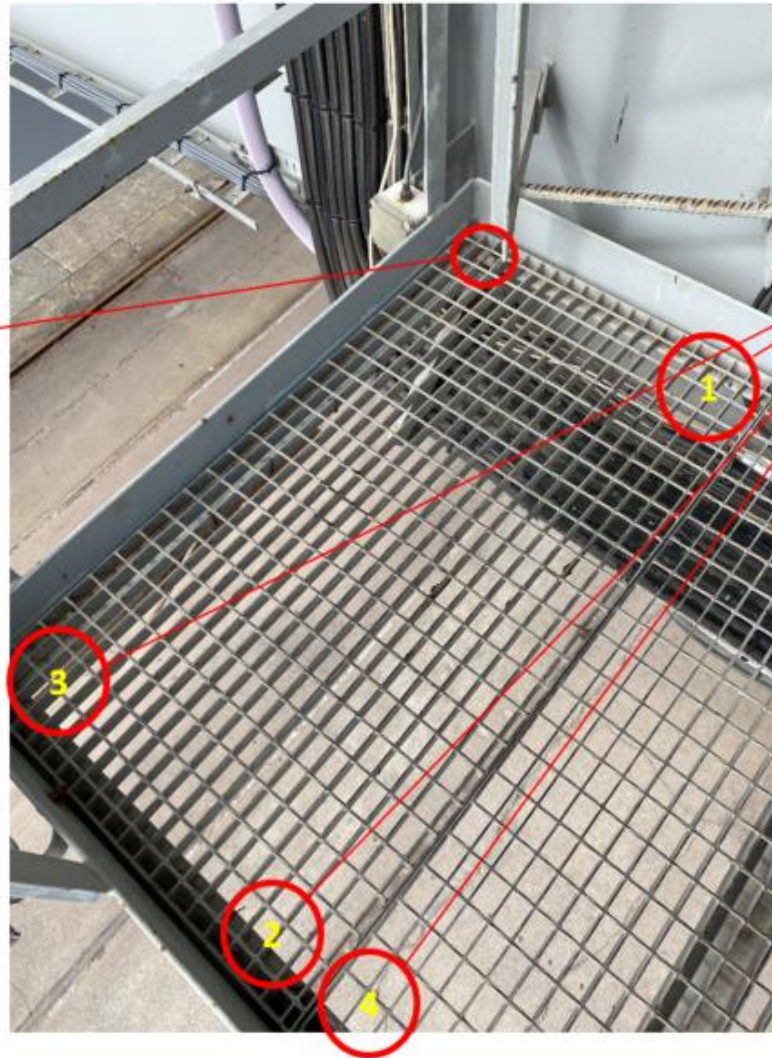
Crane 42 (1st Level)
Looking for evidence &
seeing the indicators

Only 1 x Clip
retaining whole
panel

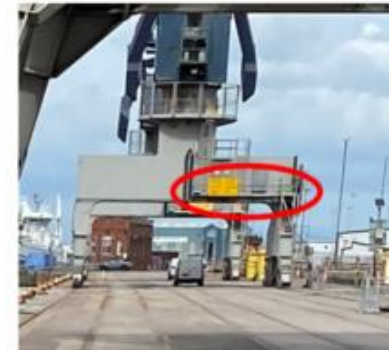
4 Clips missing
means whole
panel loose

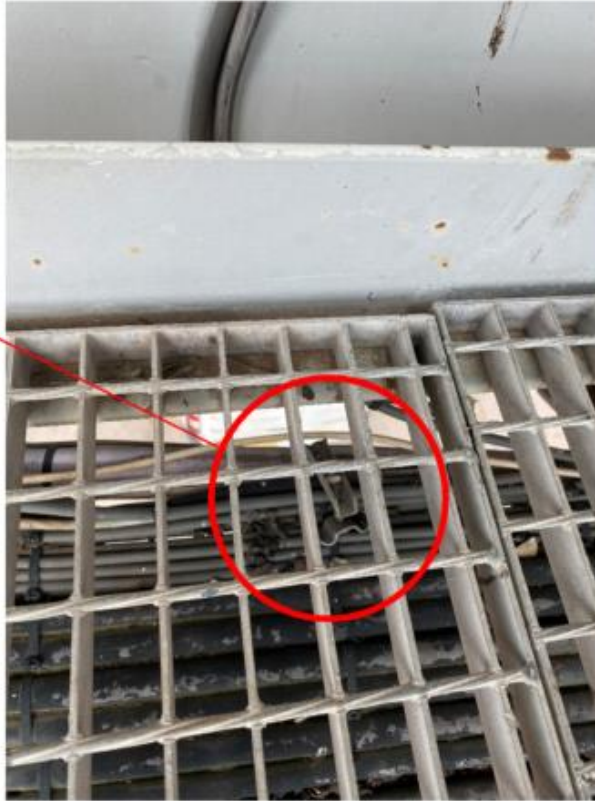
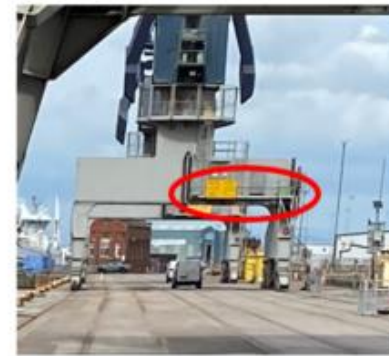
Crane 42 (1st Level)

Clip lying on Cable
Tray

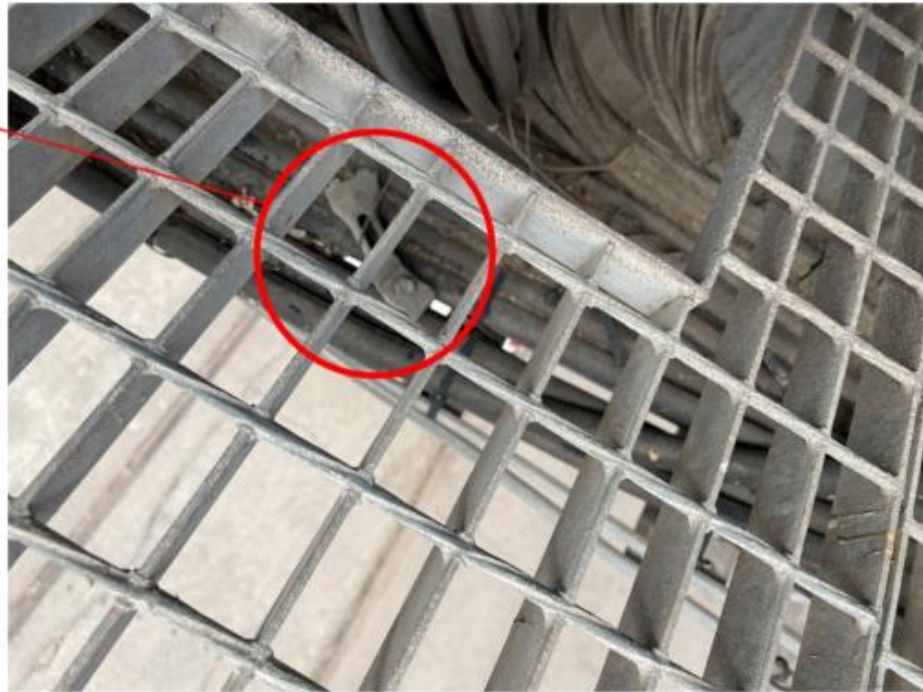
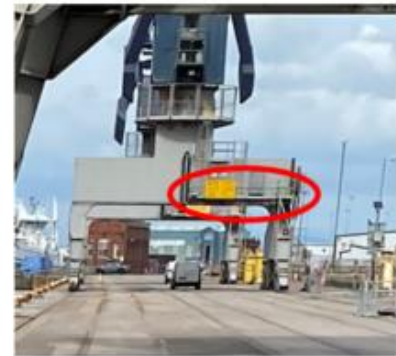
Crane 42 (1st Level)

Clip lying on Cable
Tray

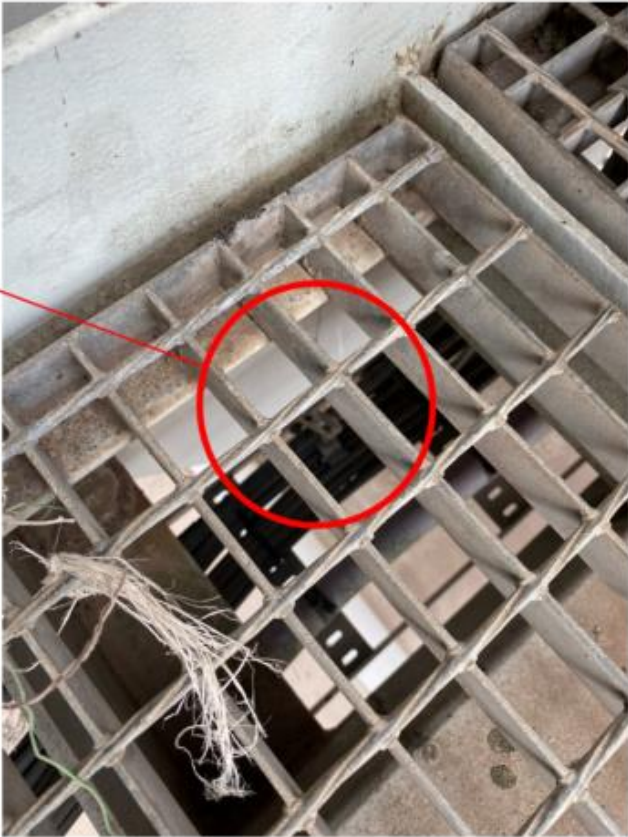
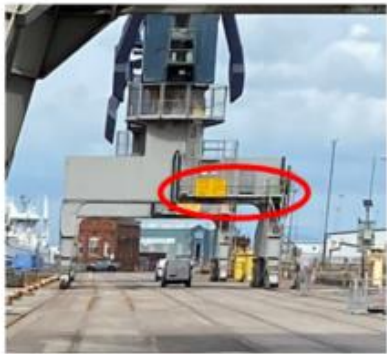
Crane 42 (1st Level)

Clip lying on Cable Tray

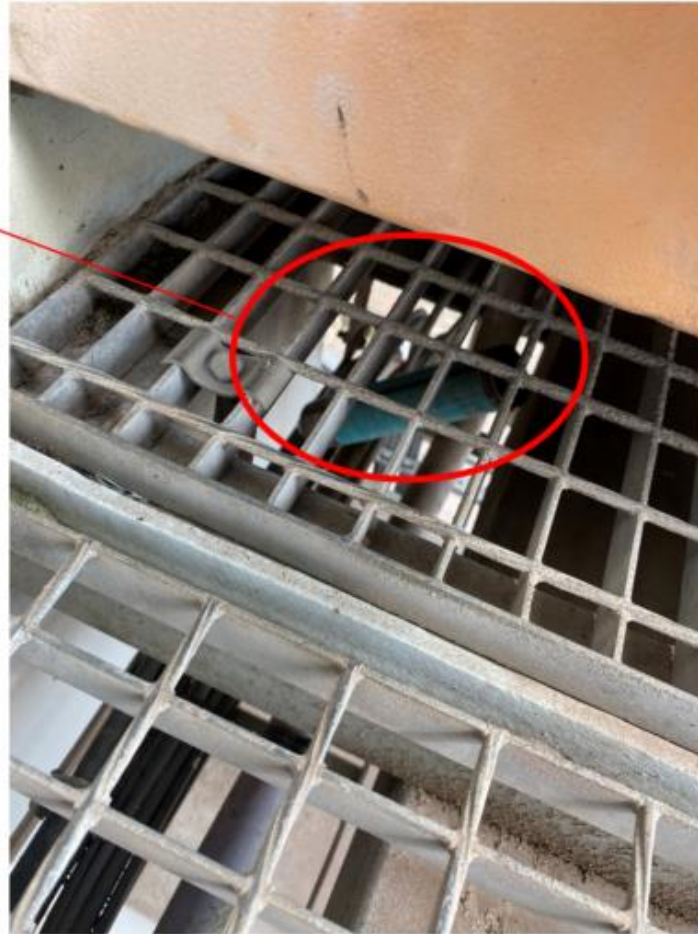
Crane 42 (1st Level)

Greasing Tube
lying on Cable
Tray

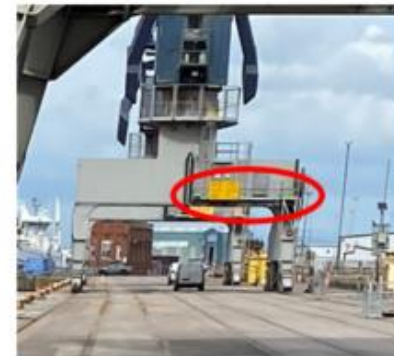
ADDITIONAL POTENTIAL
DROPPED OBJECT FIND
