Red Stripe

Subject: Potentially fatal accident: Worker injured by falling load
Location: Strip Products MLE, IJmuiden, Sinter plant
Date: 20 June 2019 **Date of incident:** 17 December 2018
Further information: Luuk Roggen (+31 6 11 62 33 77)

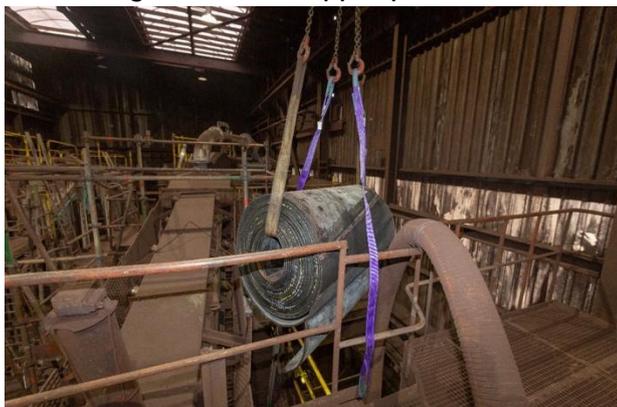
Remaining load on the upper platform

- Two rolls of conveyor belt were lifted simultaneously.
- It is not clear how the roller conveyor belt, which was dropped, was shackled.
- The work permit and BOWR (used in IJmuiden, translation is: assessment list work and surrounding related risks) process was not carried out correctly. This concerns the content, the associated procedure and the way in which we comply with the measures relating to the identified risks (behaviour).

- Consult with the supplier of lifting belts about the (possible) shortcomings in the instructions for use with regard to the extension of lifting belts.

- Within HTD, all employees who have completed at least the training course on load handling are given an instruction on how to handle slings, steel slings and chains. This instruction will be made available to the IJmuiden site and the contractors.

- QHSE 3.14 describes the conditions under which a lifting plan is required. The regime manager of hoisting and lifting equipment is working on the further development of this for HTD so that there is a defined description about the necessity and manner of completing the hoisting plan. As soon as it is ready, the protocol will be made available for the IJmuiden site and the contractors.

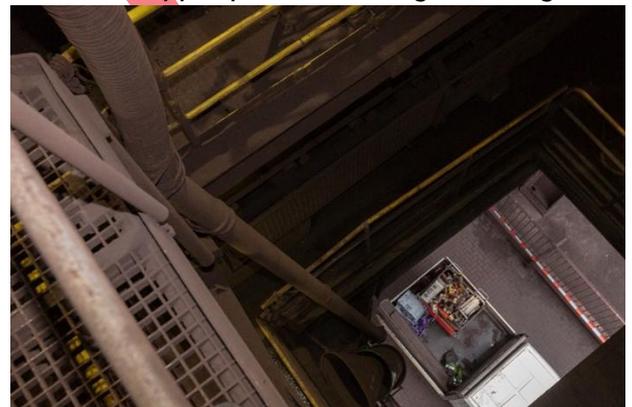
After picking up the work permit, the two mechanics drove to the location where the rolls could be lifted through a hoisting hole. It was agreed that mechanic L would start working on the two conveyor belts and mechanic B would go to the upper platform (15 metres above the means of transport) to operate the crane. At the sign of mechanic L, mechanic B was going to lift the two conveyor belts. From the upper platform, mechanic B had a good view on the load. Mechanic L had meanwhile walked away from the means of transport and was outside the field of vision of mechanic B. When the load was up, one roll of conveyor belt suddenly fell down and bumped into mechanic L via the railing of the lower platform, the landfill chute and the side of the transport trolley.

View from upper platform through hoisting hole
